Detailed Site Investigation

**Laing O'Rourke Compound, 32 - 34 Harris Street, North Saint Marys NSW
2760**

A101021.0125.01 | DSI.v4f | Date: 21.08.2024

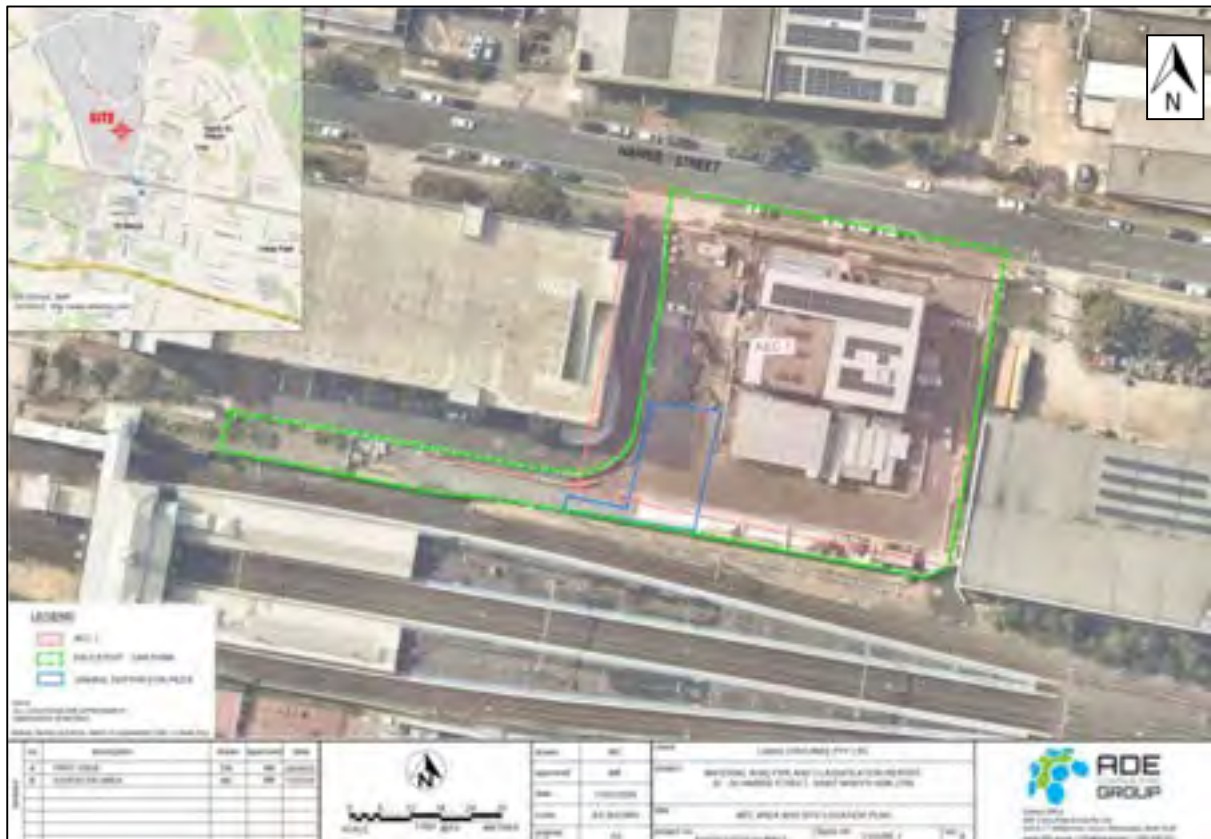
Figure 1. Site layout.

The site is located at 32 - 34 Harris Street, North Saint Marys NSW 2760. Refer to Appendix A – Figure 1.
